# AG-SB-2017-04-B-EN – Cavalon rudder cable wirelocking

This Service Bulletin is applicable for Cavalon, where the turnbuckles in the rudder control cable to the pedals were not wirelocked (see fig.2).

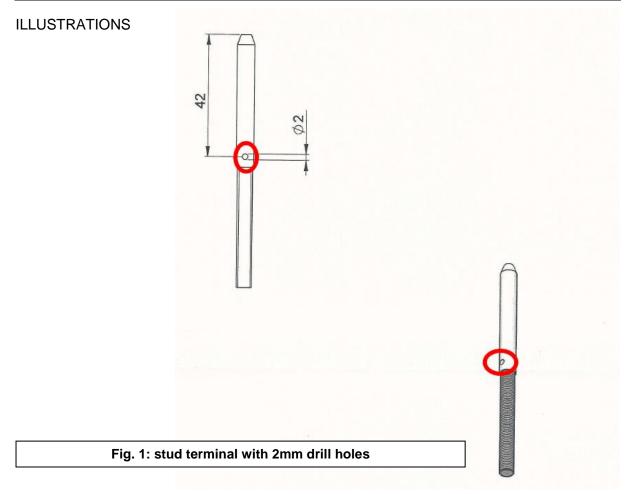
A case was found where the turnbuckles in the rudder control cable to the pedals were not wirelocked.

The turnbuckles have low axial loading and are secured with engineers paint. Wirelocking is a required additional locking measure.

- Remove the coverplate in the footwell to the rudder control cable.
- 2 Inspect that the turnbuckles in the rudder control cable to the pedals were wirelocked.
- Rectification: (if necessary drill a 1.5-2mm diameter hole in the cable end terminal as shown in the drawing (see fig.1), taking care to centralise the hole. Deburr, and remove waste from aircraft) secure it with lockwire.
- 4 refit the coverplate in the footwell.

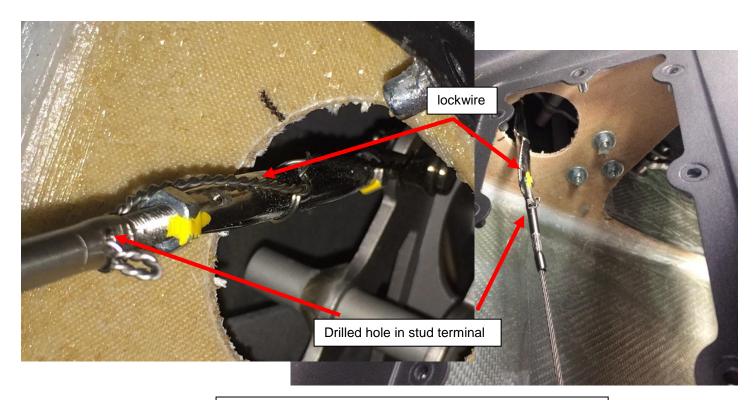
Fig. 2: wirelocked turnbuckle in the rudder control cable

- Inspect that the turnbuckles in the rudder control cable to the pedals were wirelocked.
- Rectification: secure it with lockwire.
