## AG-SIL-2017-01-A-EN – Calidus frame upper mast side plate

### **Service Information Letter**

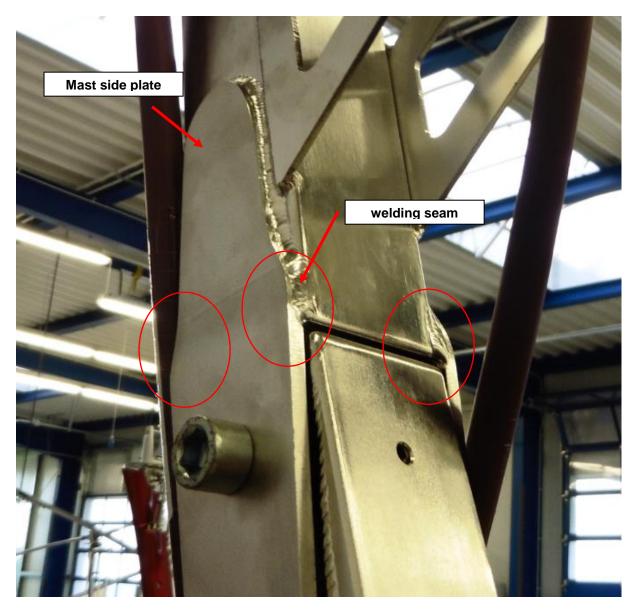
Fig 1: Calidus upper to lower mast connection new

A case was found with a severe crack in the mast side plates that connect the upper mast to the lower.

The purpose of this SIL is to highlight the need to thoroughly check this part (see fig.1).

- check the upper to lower mast side plates thoroughly for cracks (see fig. 1 and 2)
- check the weld seams of the side plates to lower mast for cracks (see fig. 1)
- Rectification: replace the main frame top, Calidus (upper mast) if cracks are found

- 1 Remove the mast fairing.
- 2 Check the side plate and the weld seams of the side plates to the mast for cracks (see fig. 1 and 2). Use appropriate equipment such as magnifying glasses.
- If cracks are found: Measure the distance between the the holes (85 mm or 100mm). Order the appropriate 3 spare part.
- 4 If the mast is to be replaced, replace as per the AMM and record the action in the aircraft logbook or documents. If not to be replaced, note in the aircraft logbook or documents that the inspection has been completed with the result found.
- Refit the mast fairing and any other removed item as per the AMM 5

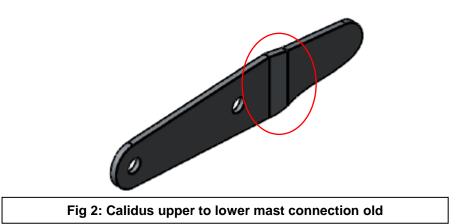
Check carefully here, 4x places
