Title: MTO Series Airframe Inspection			
AG-SIL-2019-02-B-EN		Compliance Category:	
Applicability		A - MANDATORY	
Aircraft type & model: All AutoGyro MTO Series	Affected aircraft serial numbers: All AutoGyro MTO Series	B – RECOMMENDED C - OPTIONAL	
The maintenance manual to be referenced is this stated or subsequent issue.		As per AutoGyro website	
This form is the response from AutoGyro GmbH either against a problem found in the product in service requiring a containment or rectification action, or as service information for aircraft modification incorporation. For help, contact AutoGyro on 49(0)5121 88056-00, or email airworthiness@auto-gyro.com.

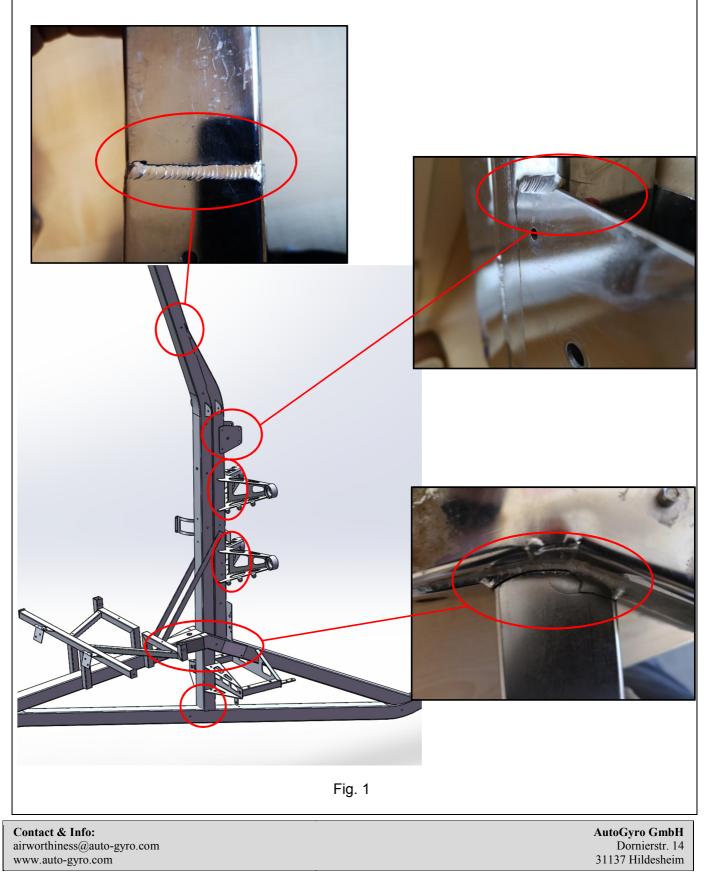
These aircraft have now accumulated many years and hours in service, resulting in service issue reports submitted to AutoGyro. Within these AutoGyro has been advised of cracks in the mast root, and the weakening of this area leading to cracks in the upper weld area of the rear strengthening tube, and pre-rotator gearbox mounting plate attachment to mast area.

Inspect the frame in accordance with the current 100hr service document AG-F-PCA-MT, paying particular attention to the areas noted below (Fig. 1).

They are long term fatigue based, dependent on operational usage, and controlled by the 100hr service inspection interval. Repair is possible and is described in SRA-016 (mast) and SRA-019 (engine mounts).
