## SERVICE BULLETIN No. UL 01/2017

#### **PRECAUTIONARY INSPECTION OF SR 3000/3N PROPELLERS**

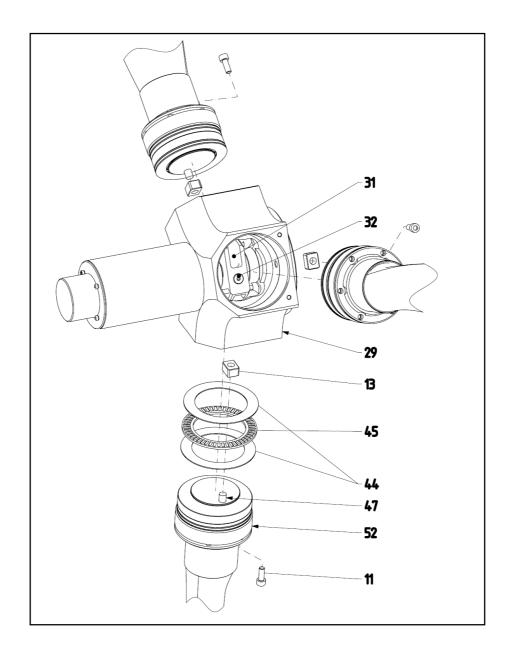
- 1. Remove securing wire from three pairs of Allen head screws **pos. 11** on propeller blade retention nut. Use 5mm Allen key to gradually loosen the screws, and remove them.

- 2. Loosen retention nut **pos. 52** using wrench P-303 and use your hand to unscrew retention nut from propeller hub. Pull propeller blade from propeller hub. If blade does not leave the hub, it sticks to walls of the hole by grease layer. Try to rotate the blade and pull it at the same time.

- 3. Remove axial bearing **pos.44, 45,** and slider **pos.13** from the space where propeller blade was, unless the parts were stuck to propeller blade by grease layer and have not been removed along with blades. Use grease to stick the parts onto ferrule of removed propeller blade.

- 4. Put protective pouch onto removed blade and secure it by tape to ensure that bearings and sliders cannot get lost.
- 5. Remove propeller blades 2 and 3 in the same way.
