Service Information Letter

Title: IVO Propeller - Lubrication of Shaft			
AG-SIL-2018-04-B-EN		Compliance Category:	
Applicability		A - MANDATORY	
Aircraft type & model: All aircraft fitted with an IVO propeller	Affected aircraft serial numbers: All aircraft fitted with an IVO propeller	B – RECOMMENDED C – OPTIONAL	
The maintenance manual to be referenced is this stated or subsequent issue.		As per AutoGyro website

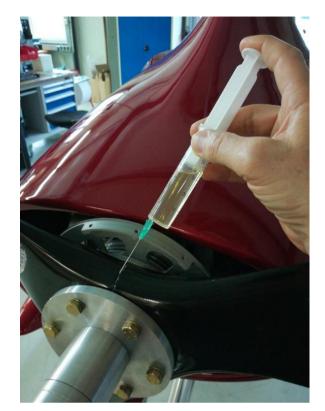
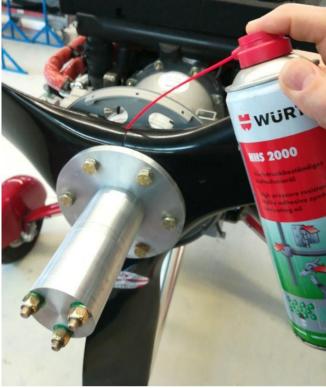
Position without spinner

- 2. Ensure that the gap between one pair of blades is uppermost (two blades are in ten-to-two position)
- 3. Using a suitable implement, liberally introduce the lubricant into the gap between the blade roots (accessing through the holes in the spinner plate if fitted). Ensure no lubricant contaminates the brush slip ring contact plates of the IVO propeller thoroughly clean if contaminated.

- 4. Turn the prop 120° and repeat steps 2 and 3. Repeat this step one final time
- 5. Ensure the area around the propeller is clear, turn on the aircraft power supply and operate the coarse/fine rocker switch (connect an external power source to the aircraft if required)

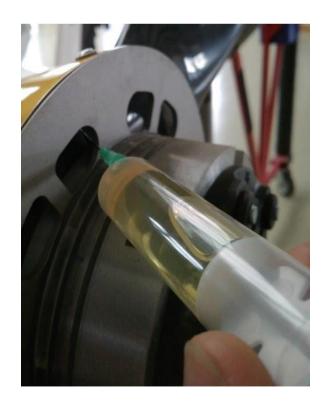
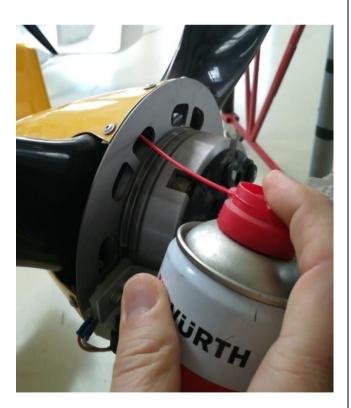
Position with spinner

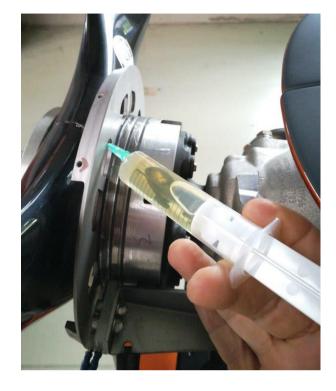
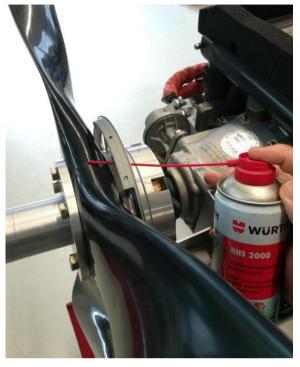
Position with spinner (spinner removed for visual purposes)
These photos demonstrate two alternative methods of introducing lubricant, either with
Ballistol via a syringe or HHS2000 as a pressurised spray.
